## A Review of the San Clemente Dam Removal & Carmel River Removte Project

Project Roles: 1) CDFW rep 2001-2006; 2) Technical Advisory Committee member for MPWMD 2006 – 2015

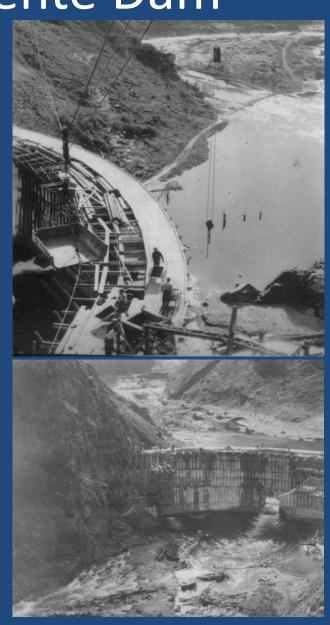
- Constructed in 1921 by Del Monte Properties, later sold to California Water and Telephone Company; Purchased by CAW in the 1960's
- ➤ 106 feet tall concrete arch dam Reservoir storage of 1,425/2,136 AF
- Spillway crest elevation of 525 feet -Spillway capacity of 20,800 CFS
- Declared seismically unsafe in 1992
- Ceased being used as a water supply in 2001 due to sedimentation & ESA
